Beckfoot Priestthorpe School - Accessibility Action Plan.

Updated: 10/01/2025

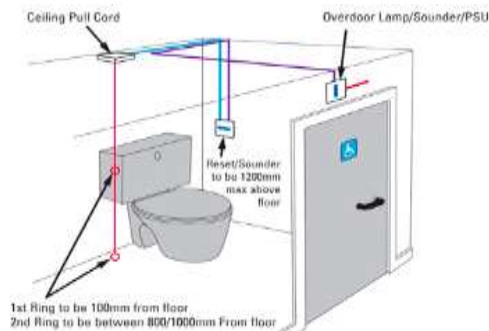
13.11	<p>The reset and exit button were directly next to each other in the facility in the hall, which could cause confusion. These were positioned at approximately 1160mm from ground floor level. The cord alarm in this facility did not feature bangles at two heights.</p> <p>The cord alarm in the nursery facility was looped onto the grab rail. The reset was positioned behind items and would not be easily accessed.</p>	<p>Implement a management procedure to ensure that cord alarms are always kept loose and not tied up.</p> <p>Ⓜ According to BS8300 - An emergency assistance pull cord should be sited so that it can be operated from the WC and from an adjacent floor area. The emergency assistance pull cord, coloured red, should be provided with two red bangles of 50 mm diameter, one set at a height between 800 mm and 1000 mm and the other set at 100 mm above floor level.</p> <p>Both facilities should include an alarm reset button, that is well contrasted from its surroundings, in its correct position on the adjacent wall to the WC at a height of 800mm -1000mm, free from obstruction.</p>	N/M

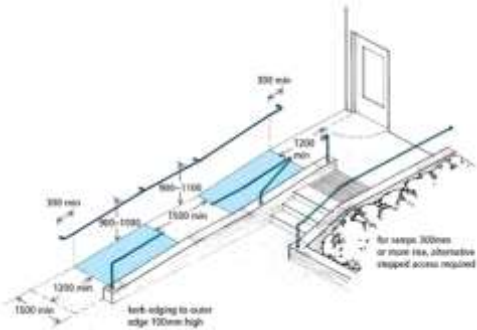
<p>3.2</p>	<p>Handrails were not provided to the ramp leading towards the site management and storage area, or the ramp leading into nursery.</p> <p>The ramp leading into the area near to the main hall had a handrail to one side only.</p>	<p>BS8300 compliant handrails should be installed to both sides of the external ramps.</p> <p>Any handrail provided should have the required 300mm horizontal landing extensions with the entire handrail located at a height of 900mm from the slope and landing surface. The handrails should also be coated with nylon or a suitable alternative to ensure that they are not cold to touch.</p>

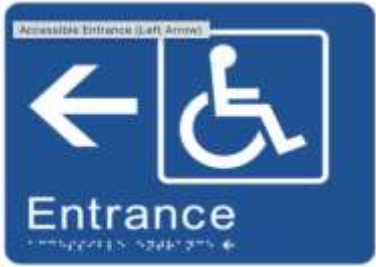
<p>5.4</p>	<p>Steps were required at the main entrance. The auditor was informed of potential future developments for this entrance to be ramped to avoid the extended route around the school. The height of the steps was approximately 1500mm.</p> <p>Signage was provided to direct people to an alternative entrance. The phrase “disabled access” requires changing.</p> <p>Steps were required into the trust area; the alternative entrance was not signposted from here.</p>	<p>The access limitations of the premises and the alternatives must be communicated via the website.</p> <p>Suitable signposting should be provided to direct disabled people to an alternative accessible entrance. Any signage provide should feature the access symbol and correct directional arrow. The alternative entrance must be open and available for use or have suitable procedures in place to provide assistanc</p>

<p>Should a ramp be constructed at the main entrance, it must comply with BS8300 and ADM-2:1.26 requirements. Any permanent ramp must be a maximum 1:12 over a maximum going of 2m, it should be a minimum 1.2m wide and feature 1.2m landings at head and foot, handrails to both sides and a contrasted sloped surface.</p>	<p>M/ST</p>

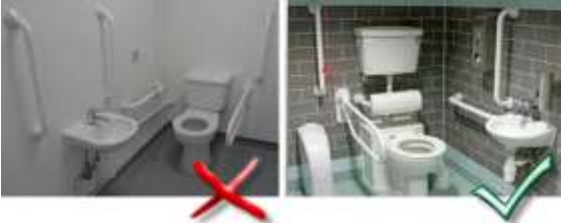
<p>13.6</p>	<p>Suitable lever style taps were provided to both facilities.</p> <p>One hand wash basin in the nursery featured turn style taps which may not be suitable for someone with limited dexterity in their wrists.</p>	<p>The turn style taps should be replaced with lever style, this will aid people with limited dexterity in their wrists.</p> <p>According to BS8300 - Taps should either be mixer taps with an up and down action to control water flow or individual hot and cold lever operated taps with not more than a quarter turn from off to full flow.</p>	<p>M</p>	
<p>13.7</p>	<p>The grab rails provided to the facility in the hall were not well contrasted against their surroundings.</p> <p>Grab rails in the facility near to nursery were well contrasted.</p>

<p>The grab rail set in the hall should be replaced with a new BS8300 compliant set that offers colour contrast.</p> <p>A difference in LRV (Light Reflectance Value) between rail and background of 30 points is considered reasonable. In accessible WCs a blue rail set on white walls is a common accessible combination.</p>	<p>M</p>

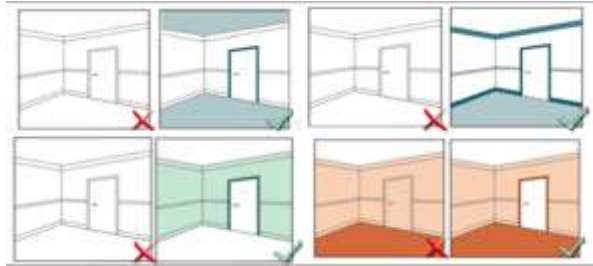
8.1	<p>Most doors across the school were clearly distinguishable from the surroundings.</p> <p>The door leading to the office (room 29), near to the WC facilities by the hall, and the internal face of the door by the upstairs offices, were not distinguishable from their surroundings.</p>	<p>Ideally all doors should have contrast against the surroundings upon which they are seen. The doorway should be easily identifiable when the door is in the closed position, and when the door is in the open position.</p> <p>This could be achieved by painting the door frames a contrasting colour. Adding colour contrast will aid people with impaired vision.</p>

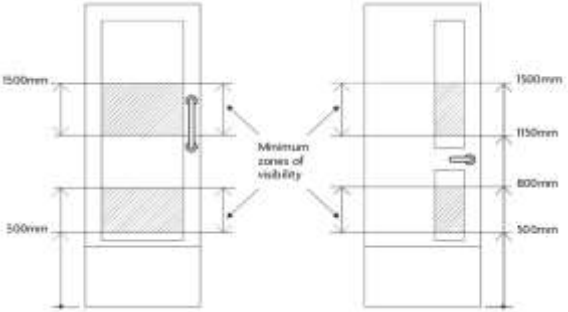
<p>8.3</p>	<p>Most doors featured suitable vision panels.</p> <p>Doors on the first-floor featured vision panels to the top areas of the door only.</p> <p>The doors in nursery featured vision panels that were covered, which may be for safeguarding purposes.</p>

<p>Install new BS8300 compliant doors with vision panels to the first floor.</p> <p>☒</p> <p>Vision panels need to be included in frequently used doors where privacy (toilets etc.) is not required with a minimum visibility zone between 500mm and 1500mm from floor level and located at the side of the leading edge.</p> <p>☒</p> <p>Glass should comply with BS6206.</p> <p>☒</p> <p>It is recommended that site management implement a procedure to ensure that the temporary notices are not on the vision panels. This will prevent a potential collision hazard. If privacy is required, blinds or a suitable alternative could be installed.</p>	<p>M</p>

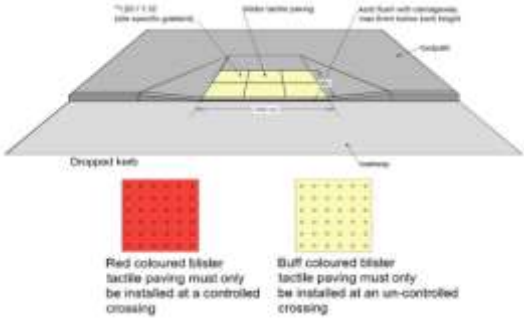
<p>1.2</p>	<p>The crossings on approach to the school featured dropped kerbs; however, tactile paving was not always provided, which could assist people who are partially sighted.</p>	<p>Site management should undertake liaison with the appropriate Council Department to provide tactile paving in the area to aid people with impaired vision.</p>

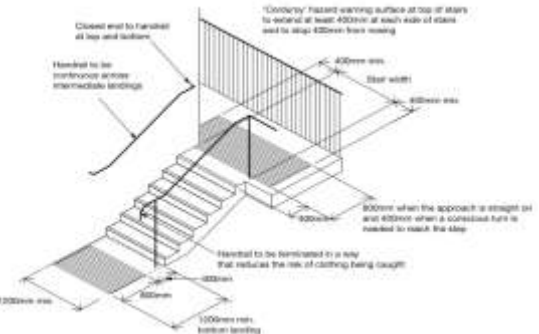
4.1	<p>Tactile warnings were not provided to the external steps surrounding the school.</p>

<p>Implement a rolling programme to install tactile paving to the top of the external steps throughout the site.</p> <p>☒</p> <p>BS8300 - To give advance warning of a step, tactile paving with a corduroy hazard warning surface should be provided at the top and bottom of each flight, excluding intermediate landings with continuous handrails. Where the approach to the stair is wider than the flight, the tactile surface should extend beyond the line of each edge of the flight.</p>	M

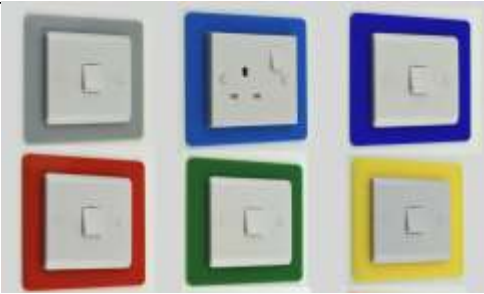
<p>16.2</p>	<p>Light switch plates provided across the school were not well contrasted. Some of which were positioned high from ground floor level and may not be accessible for all user</p>

<p>At the next refurbishment for the sites, it would be beneficial to change the existing light switch plates with alternatives that have a grey/silver plate.</p> <p>Alternatively, light switch plates with a contrasting surround could be used.</p> <p>This will ensure that they are easily located by people with impaired vision.</p>	<p>M</p>	
<p>16.3</p>	<p>Most learning spaces featured suitable blinds. There were areas on the first floor that did not feature blinds or curtains to assist with controlling glare from natural light.</p>	<p>Both natural and artificial sources of lighting should be designed to avoid creating glare, pools of bright light and strong shadows.</p> <p>Provide blinds or a suitable alternative to the first floor. Wherever possible, safe and accessible controls for opening and closing curtains/blinds/shutters automatically or by other means of remote control should be provided for use by disabled people. <u>Rods or pull cords for manually opening and closing curtains are acceptable.</u></p>	<p>M</p>
